Report on
Salinity Investigation and Updated Management Plan

Proposed Residential Subdivision
190 Raby Road, Gledswood Hills, NSW

Project 224683.00
November 2023

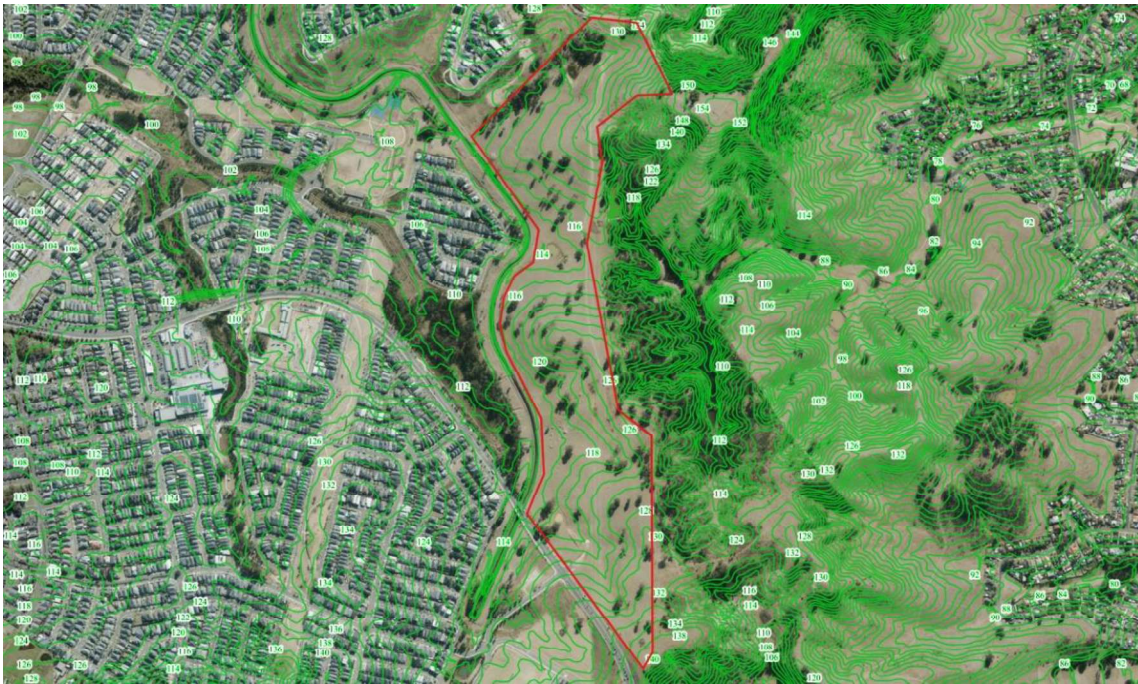
Figure 1: Site Boundary and 2 m Contours

The site boundary is shown on Figure 1.

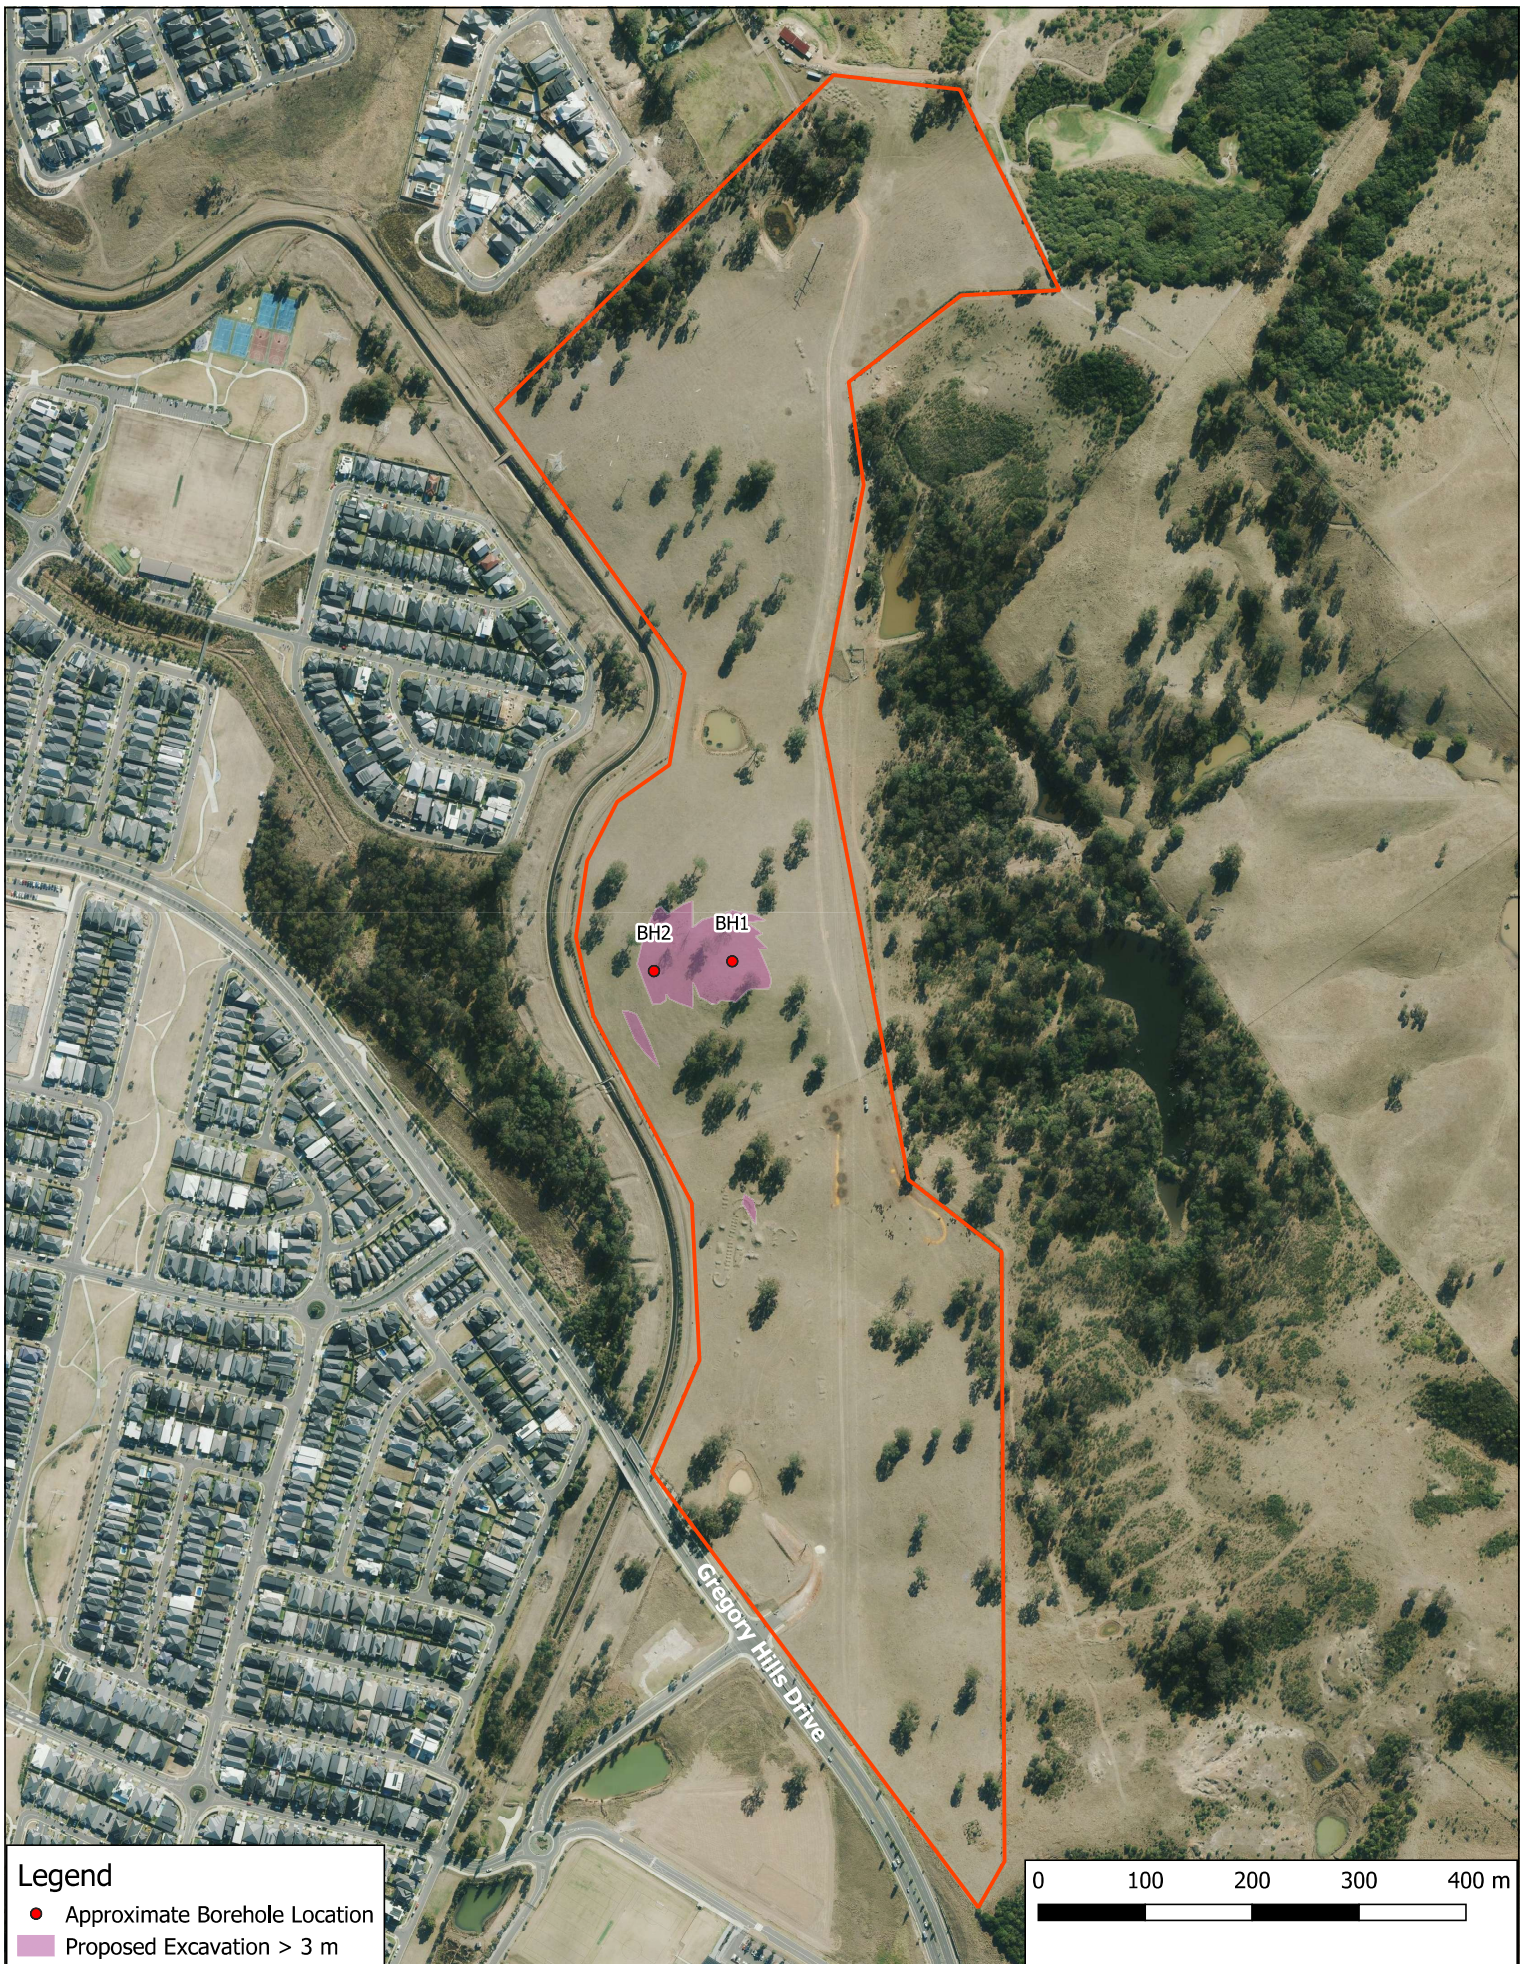
Drawing 1

- Approximate Borehole Location
- Proposed Excavation > 3 m

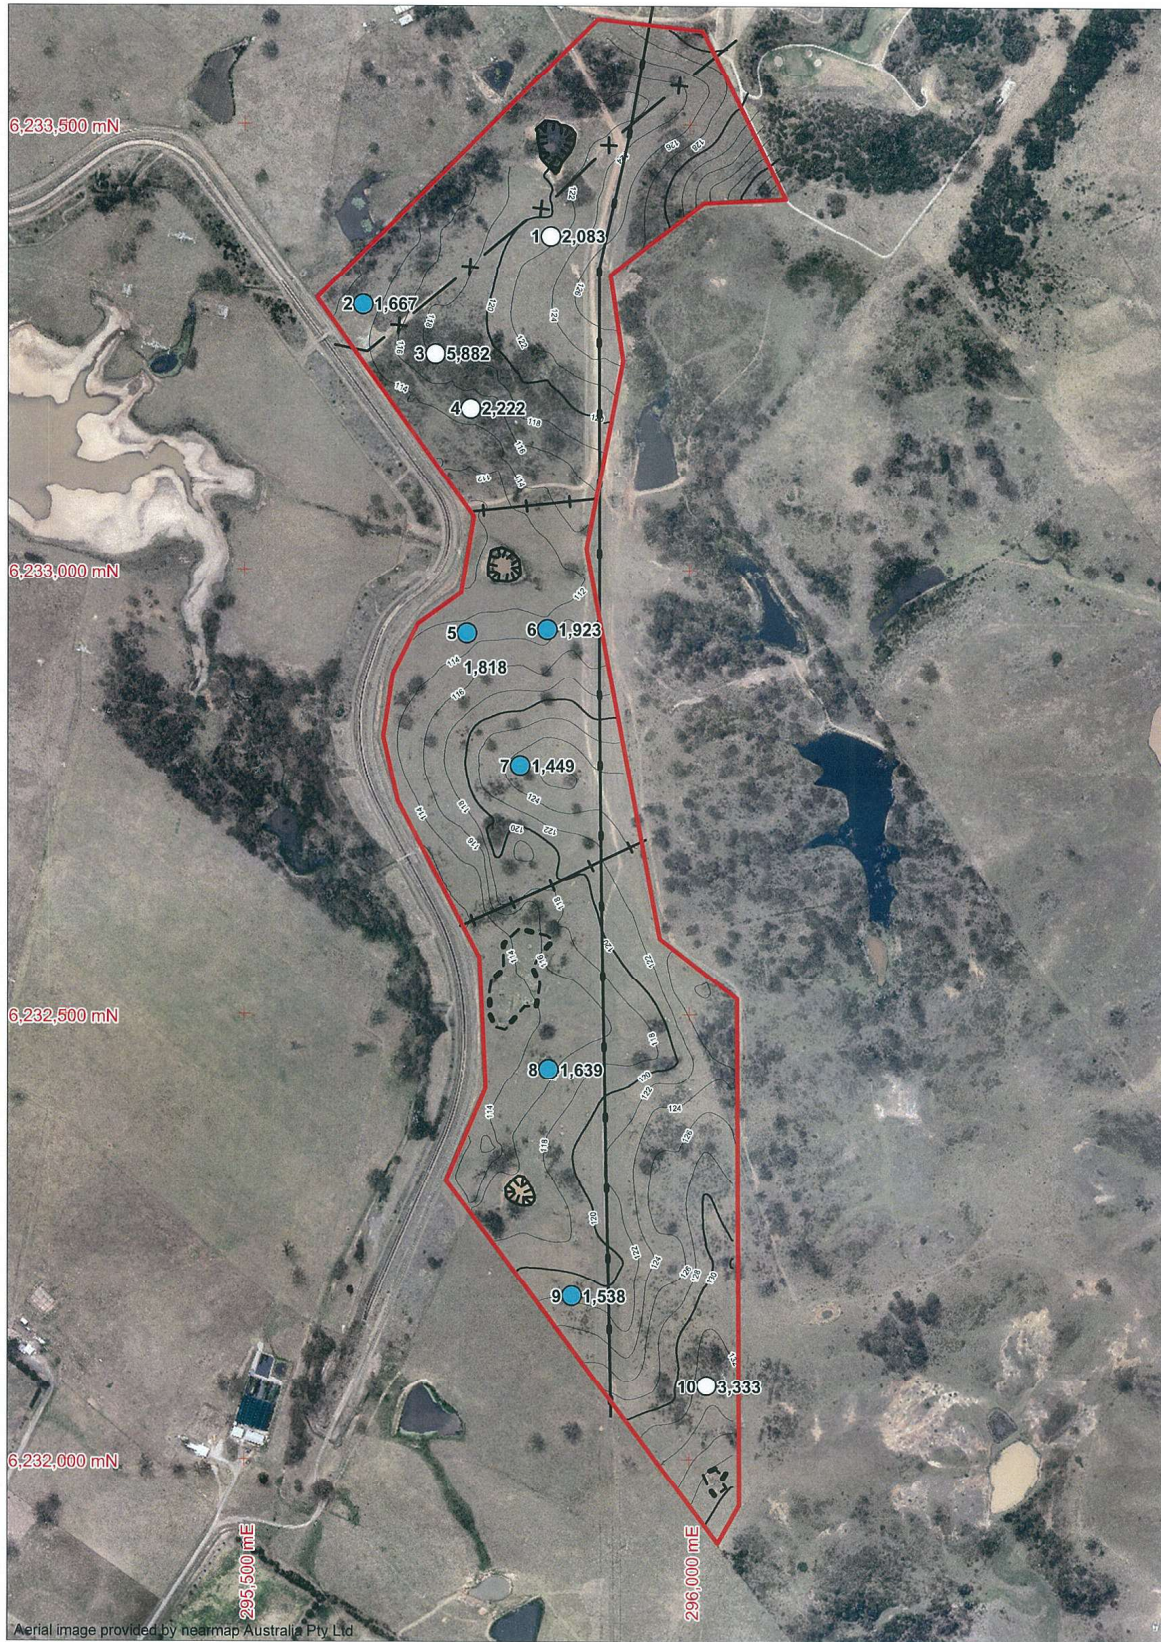
LEGEND	
	Grid: GDA94 / MGA94 (Zone 56)
	Site boundary
	Overhead transmission line corridor
	Underground gas line corridor
	Surface level contour (mAHD)
	Area of visible metallic debris
	Fence
	Dam
	Test pit location. Minimum resistivity (Ohm-cm) indicates material mildly aggressive to steel.
	Test pit location. Minimum resistivity (Ohm-cm) indicates material non-aggressive to steel.

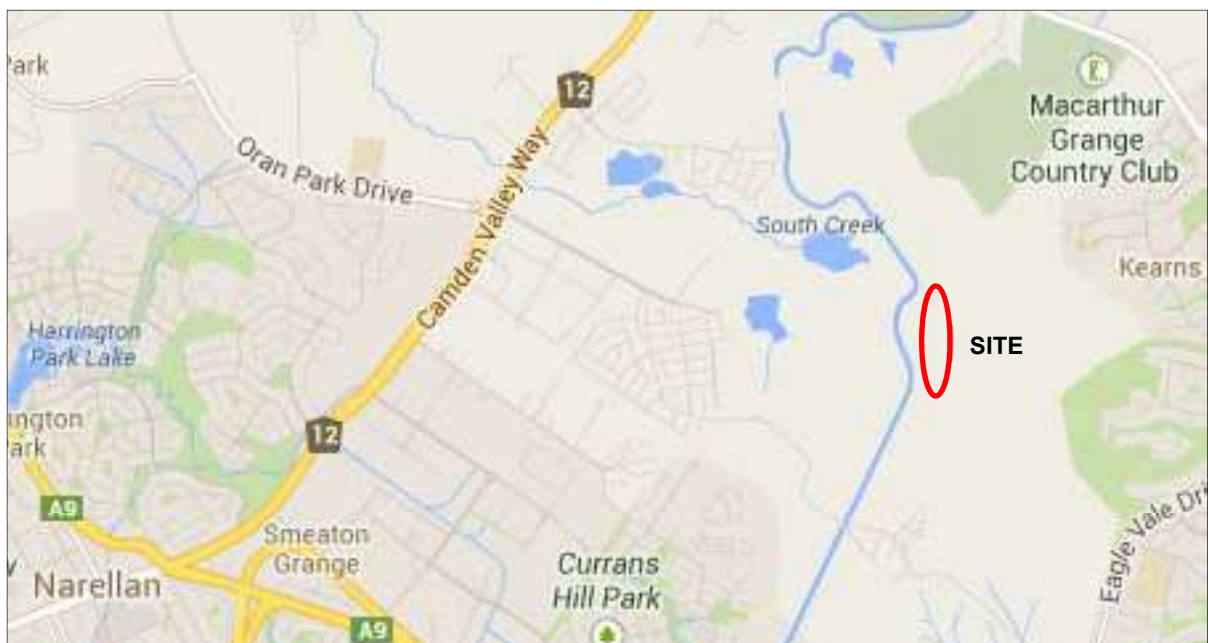
Figure 1: Site Location

The subdivision is proposed in an irregular area of approximately 40 ha and is identified as Lot 4, Raby Road, Gledswood Hills. The site is bounded to the north, south and east by vacant private land. The north-eastern corner is also bounded by the Macarthur Grange Country Club. The Sydney Water Supply Channel runs along the western boundary of the site. The site location is indicated in Figure 1 (below) and the site boundaries are shown on Drawings 1 to 8 in Appendix A.

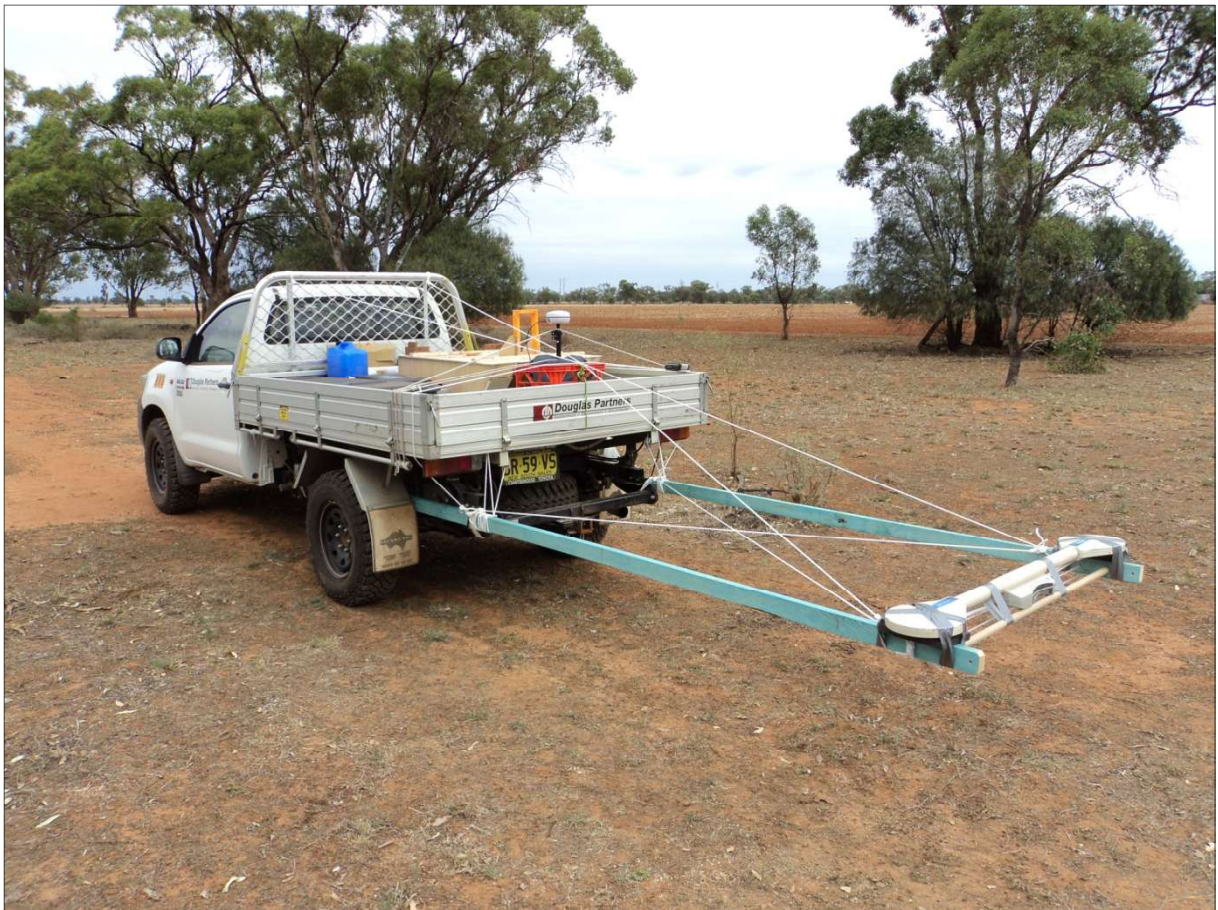
A Hemisphere S320 High Precision Differential Global Positioning System (HPDGPS) was employed to record grid co-ordinates at 1 second intervals as the survey proceeded and both positional data and ECa data were acquired at 1 second intervals to the Profiler's digital data logger.

Figure 2: Profiler on booms behind a 4WD (not this project) and DGPS antenna in tray of 4WD.

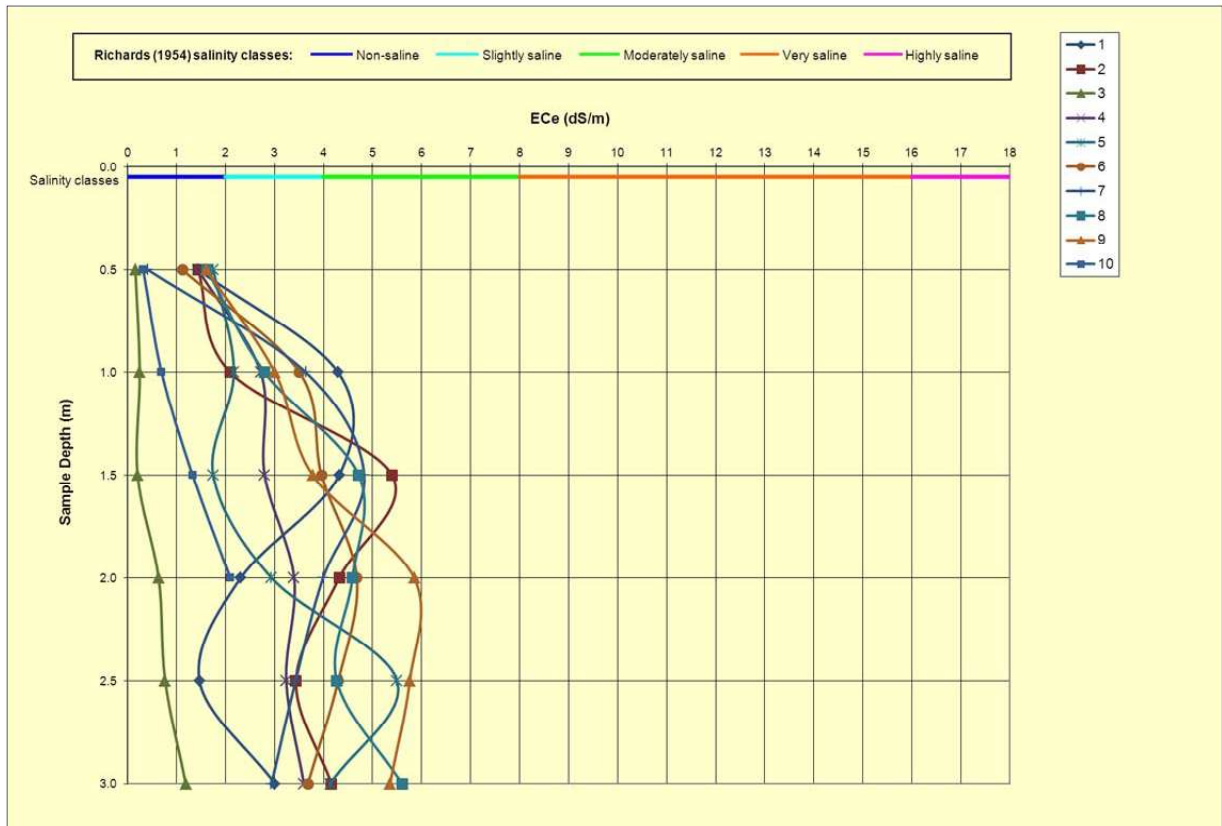
Soil sampling at 0.5 m depth intervals enabled the construction of vertical soil salinity profiles (Figure 3, following page).

These vertical profiles are generally of “normal” or “intermittent” types indicating normal water balance between infiltration and discharge (increasing salinity with depth) or some fluctuation in water levels, with residual salinity maxima in the 1 m to 2.5 m depth zone.

Figure 3: Vertical Soil Salinity Profiles

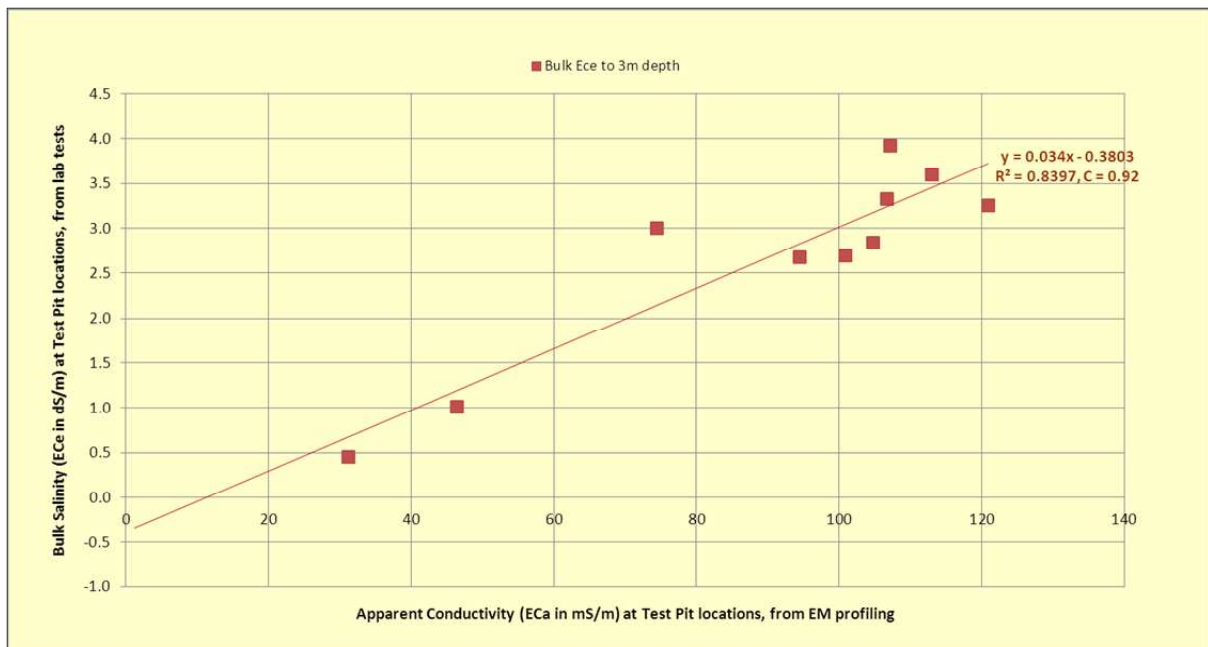
To carry out the required correlations, the 2-dimensional ECa grid surface of Drawing 3 was evaluated at the exact test pit locations and the ECa values were plotted in a scattergram (Figure 4, below) against bulk ECe values. A reasonable linear trend between these parameters (correlation coefficient of 0.92) indicates that the EM system is responding to soil salinity and that the EM data obtained provides a reasonable measure of the site salinity.

The line of best fit defines the ECe/ECa trend and provides an equation by which to convert apparent conductivities ECa (in mS/m), to estimate apparent salinities ECe (in dS/m) throughout the data set.

Figure 4 – Correlation of Bulk ECe and ECa data

The correlation equation ($ECe = 0.034 \times ECa - 0.3803$) was applied to all apparent conductivity grid data for presentation as an apparent salinity image (Drawing 5) with continuous colour spectral scales in dS/m. The 2-D surface was also contoured at the 2 dS/m and 4 dS/m levels, corresponding to

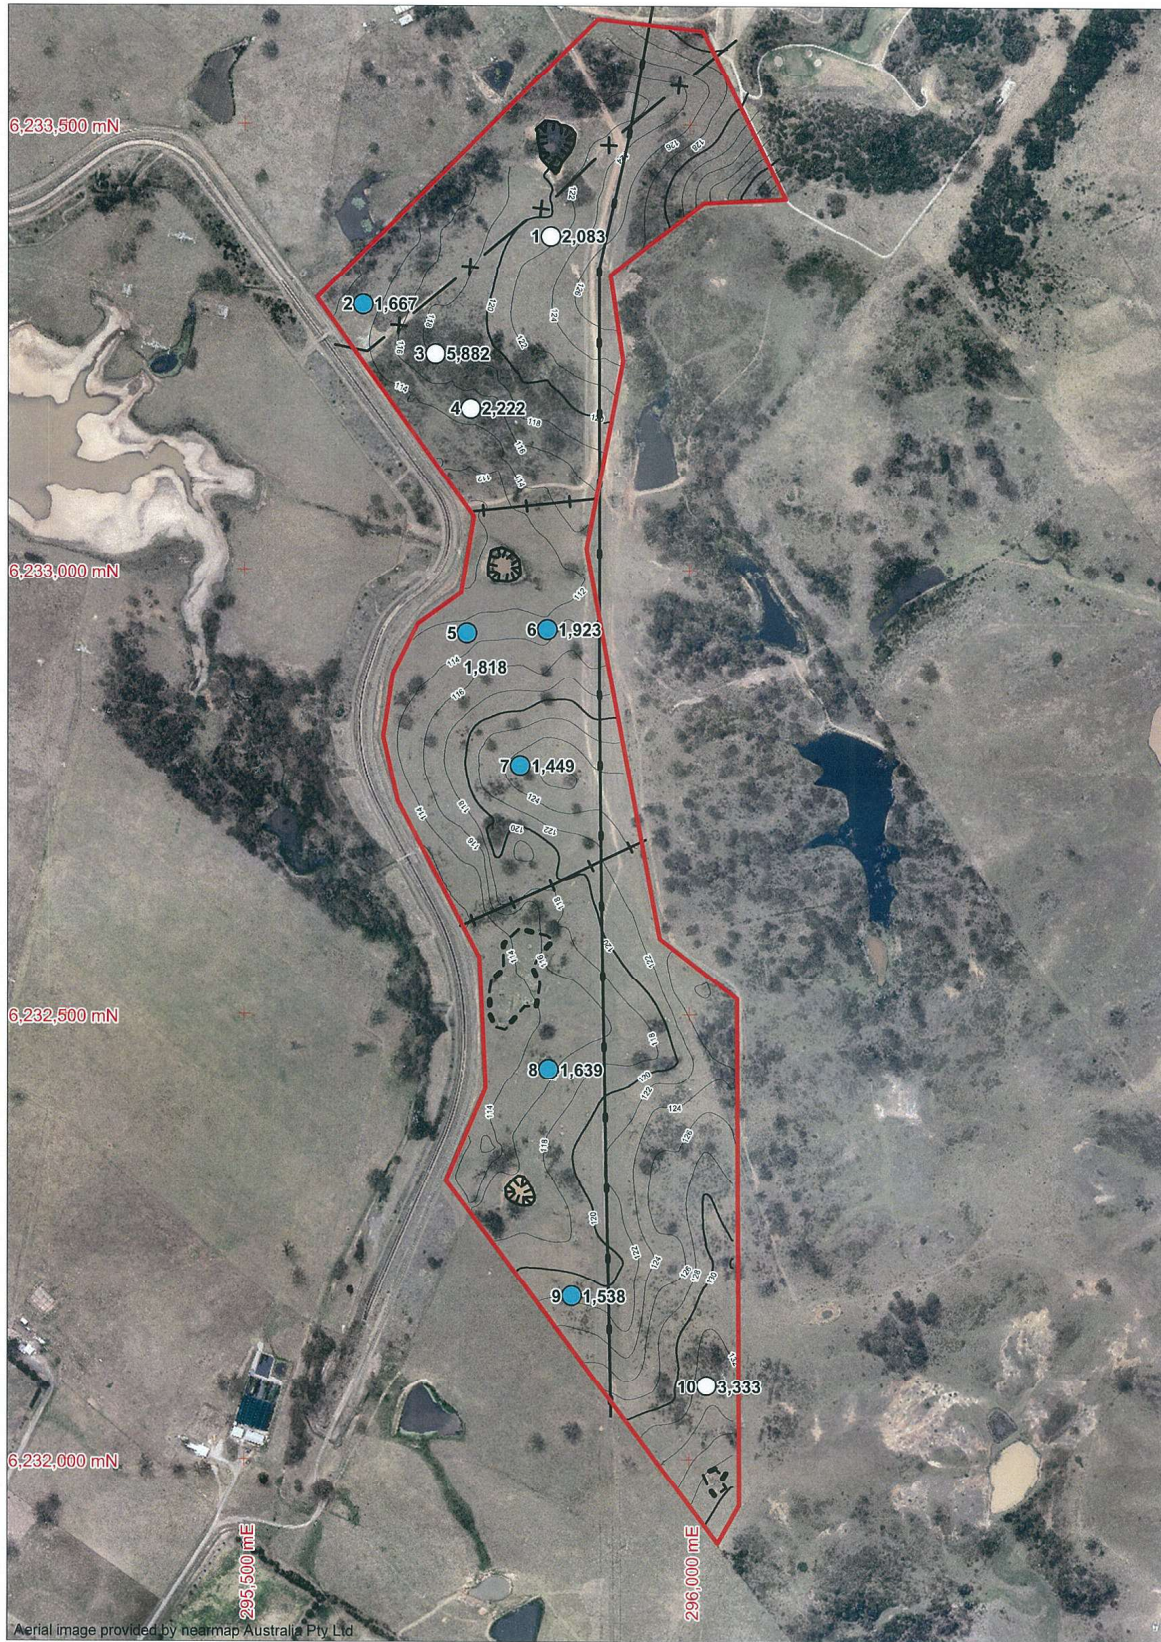
LEGEND	
	Grid: GDA94 / MGA94 (Zone 56)
	Site boundary
	Overhead transmission line corridor
	Underground gas line corridor
	Surface level contour (mAHD)
	Area of visible metallic debris
	Fence
	Dam
	Test pit location. Minimum resistivity (Ohm-cm) indicates material mildly aggressive to steel.
	Test pit location. Minimum resistivity (Ohm-cm) indicates material non-aggressive to steel.
